Slope Stability Assessment of The Garin Majjed Archeological Village Area, East of Yemen

Adnan A. Barahim, Khalid A. Al-Suba'i and Abdul Karim S. Alburahi

ABSTRACT

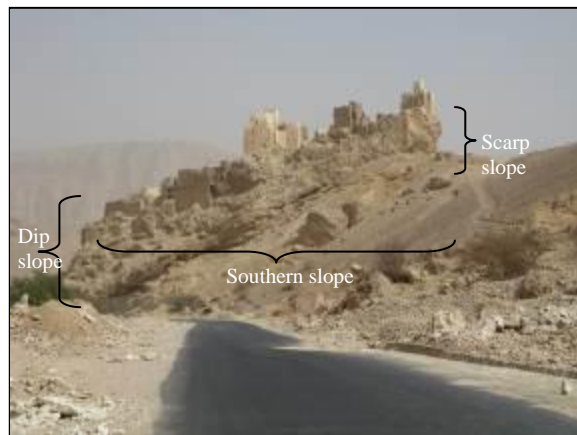
Photo (2): Side view of cuesta shape showing different slopes around the village. Photo direction to the north.

The Garin Majjed archeological village stands above cuesta shape hill with a dip (back) slope of $295^{\circ}/30^{\circ}$, scarp- overhanging slope ($090^{\circ}/OH$) and Southern side slope of $180^{\circ}/80^{\circ}-OH^{\circ}$ (photo2 & Fig. 3). The average dip of contact between two rock units of the cuesta is $270^{\circ}/26^{\circ}$. The upper part of the cuesta shape belongs to the Umm er Radhuma Formation (Upper Paleocene) which consists mainly of yellow and grey nodular limestone with some marl while the basal part belongs to Mukalla Formation (Cretaceous) which consists mainly of sandstone with some shale, silt and marl. Jeza formation (Early Eocene)

The slope is close to the main road as shown on Photo 2. It is 45 m high and 60 m long parallel to its trend. The slope inclination is $295^{\circ}/30^{\circ}$ with average dip of $270^{\circ}/26^{\circ}$ and it is daylighting at right part. According to Al-Saadi's slope classification this slope is parallel slope with 15° divergence angle and left emergent concordance (Fig. 4A & B),
